Manhole Inspection Summary

Manhole # S25K__024MH

Location Address: **1304 McHenry St**

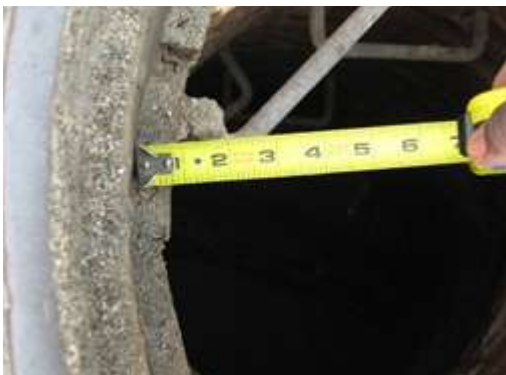
Defect 4

Frame Offset: **1** (in.) Condition: ☒ Sound ☐ Cracked ☐ Leaks

offset

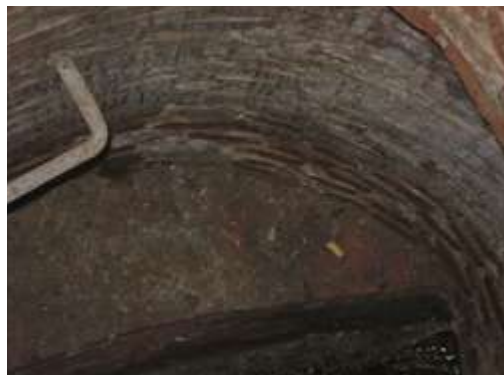
Defect 2

Infiltration: ☐ None ☐ Joint ☐ Cracks ☐ Mortar ☐ Roots ☒ **Wall**

Infiltration on barrel wall

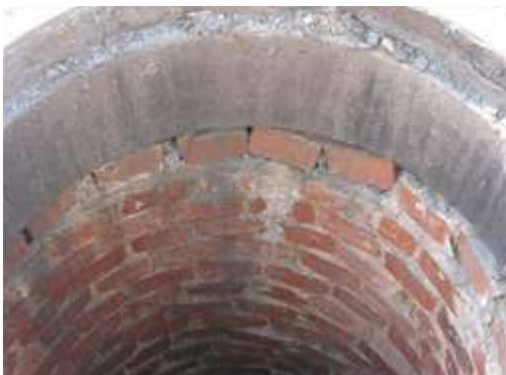
Defect 3

Condition: ☐ Sound ☐ Cracked ☐ Root Intrusion ☒ **Loose Brick** ☐ Deteriorated

Infiltration: ☐ None ☐ Joint ☐ Cracks ☐ Mortar ☐ Roots ☒ **Wall**

loose bricks, missing mortar, frame offset approx 1-2"

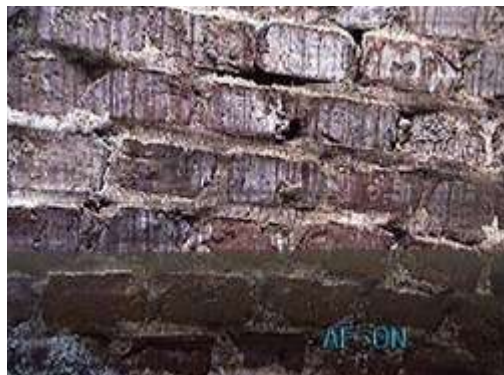
Defect 1

Infiltration: ☐ None ☐ Joint ☐ Cracks ☐ Mortar ☐ Roots ☒ **Wall**

Infiltration at corbel

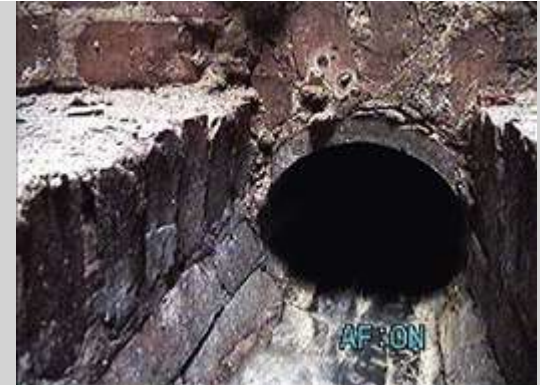
12 O'Clock Outflow

Pipe Height: **7.2** (in.) Rod and Bar (Angled)
Pipe Material: **Clay** ☐ Pipe Lined
Invert Depth: **9.71** (ft.) Flow Characteristics: **Slow**
Deposits: ☒ None ☐ Mud ☐ Sludge ☐ Debris ☐ Grease
Silt Depth: **0** (in.) Deposits Extent:
Infiltration: **None** Pipe Seal Cond: **Sound**

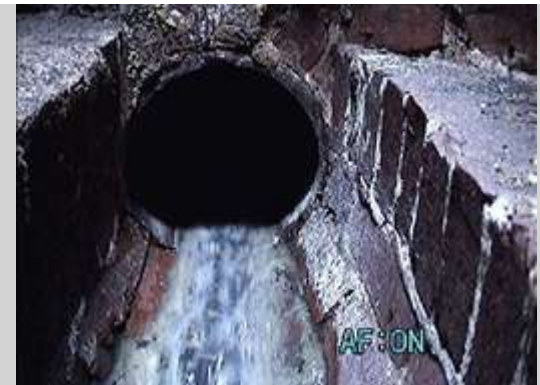
5 O'Clock Inflow

Pipe Height: **9.6** (in.) Rod and Bar (Angled)
Pipe Material: **Clay** ☐ Pipe Lined
Invert Depth: **9.33** (ft.) Flow Characteristics: **Slow**
Deposits: ☒ None ☐ Mud ☐ Sludge ☐ Debris ☐ Grease
Silt Depth: **0** (in.) Deposits Extent:
Infiltration: **None** Pipe Seal Cond: **Sound**
